ASBESTOS BULK ANALYSIS REPORT

LOG # 19074

RE: Analytical Results for 19-43504, RM #51

SAMPLE SUMMARY

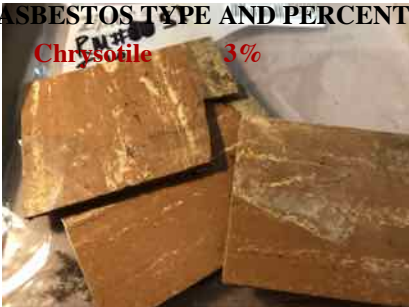
Sample #: 83948		Lt. Brown Floor Tile with White Streaks		Not Noted	
Lab #	19074-1a	Layer 1	Asbestos Containing Tile		Nonfriable
MATERIAL DESCRIPTION: Vinyl asbestos floor tile (VAT) containing mineral fillers that include 3% short/thin fibers, stubby fiber bundles, and platy grains of minerals in the serpentine family. Additional chrysotile beyond resolution by standard PLM analysis may be present.		ASBESTOS TYPE AND PERCENT:

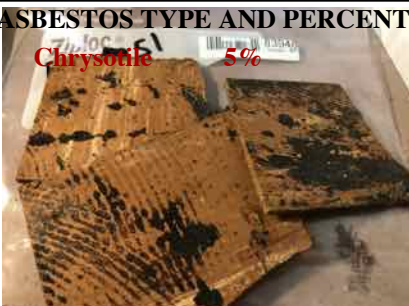
% OTHER FIBERS: Cellulose 1 % NONFIBROUS COMPONENTS: Fillers & binders 96	
Sample #: 83948		Black Tar Mastic		Not Noted	
Lab #	19074-1b	Layer 2	Asbestos Containing Mastic		Nonfriable
MATERIAL DESCRIPTION: Mastic on the under side of the floor tile is stripes of black tar containing 5% chrysotile fiber bundles, flat twisted cellulose fibers, and mineral grains.		ASBESTOS TYPE AND PERCENT:

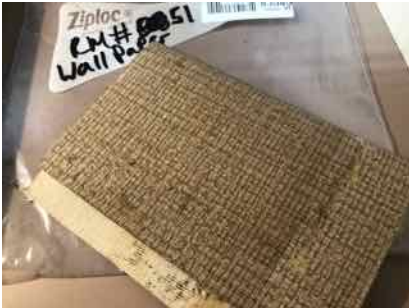
Sample #: 83949		Wallpaper		Not Noted	
Lab #	19074-2	No Asbestos Detected			
MATERIAL DESCRIPTION: Light brown vinyl wallpaper contains embedded layer of woven strands of white cellulose fibers. White glue on the under side is attached to a tan paper layer composed of cellulose fibers.

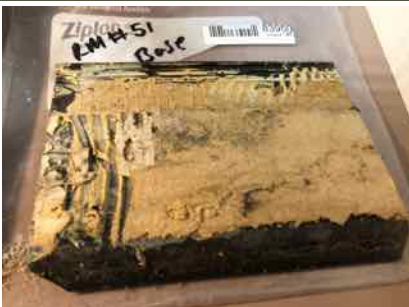
% OTHER FIBERS: Cellulose (wallpaper) 55 Cellulose (mastic) 4 Cellulose (paper) ~100 % NONFIBROUS COMPONENTS: Binders (wallpaper) 45 Pigment, binder (mastic) 96	
Sample #: 83950		Black Rubber Cove Base & Gold Mastic		Not Noted	
Lab #	19074-3a	Layer 1	No Asbestos Detected		
MATERIAL DESCRIPTION: Black rubber cove base and gold brittle mastic both contain fine mineral grain fillers.

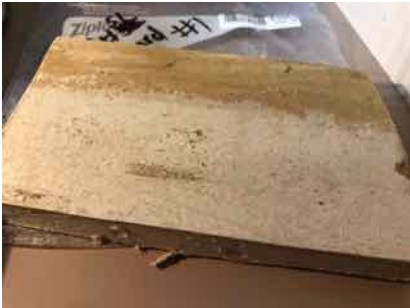
Sample #: 83950		Paper and Tape Mud		Under Cove Base and Mastic	
Lab # 19074-3b		Layer 2		<1% Asbestos	
MATERIAL DESCRIPTION: Tan paper composed of cellulose fibers. A stripe of off-white mud attached to part of the paper is interpreted as tape mud. The mud contains mineral fillers that includes fine mica visible to the naked eye, and other mineral fillers that includes less than 1% thin wavy chrysotile fibers.		ASBESTOS TYPE AND PERCENT: Chrysotile <1% of tape mud		Friable if Disturbed	
				% OTHER FIBERS: Cellulose (paper) ~100 Cellulose (tape mud) 4-5	
				% NONFIBROUS COMPONENTS: Mineral fillers & binders (TM) 95	
Sample #: 83951		1/2" Gypsum Board		Not Noted	
Lab # 19074-4		No Asbestos Detected			
MATERIAL DESCRIPTION: Gypsum Board, 1/2" thick, containing colorless glass fibers and white to tan cellulose fibers in a gypsum plaster containing fine mineral grain fillers. The plaster is bound between tan cellulose paper layers. White paint on outer surface looks like
